SECTION 10
EXPANDING AIM 65

10.1 ON-BOARD RAM EXPANSION

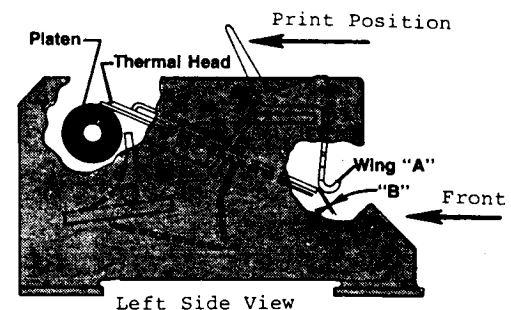
A. Release Level Print Adjustment

With the head release lever in the PRINT position, wing "A" of the level should not touch the Thermal Head group. There must be visible clearance at "B" so that the Thermal Head group may rest on the platen (see Figure 11-1a).

Figure 11-1. AIM 65 Printer Adjustments

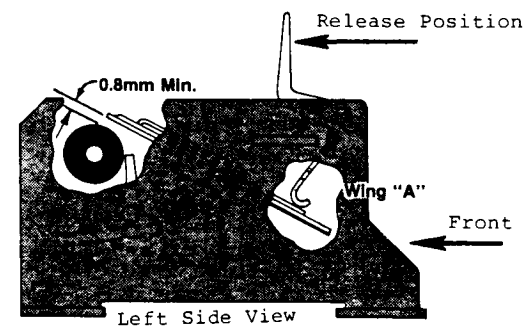
B. Release Level Release Adjustment

When the head release lever is in the RELEASE position, the Thermal Head group must be held away from the platen. Minimum clearance is 0.8mm, as shown. To obtain both these conditions, form wings "A" as necessary (see Figure 11-1b).
